Student Research papers In 1978 one of Warren Roberts' students documented a turn of the 20th century farm that had been in the same family since 1839. This house is the third dwelling, the first being a log house that was replaced after a year or two by a larger log house shortly after 1840.

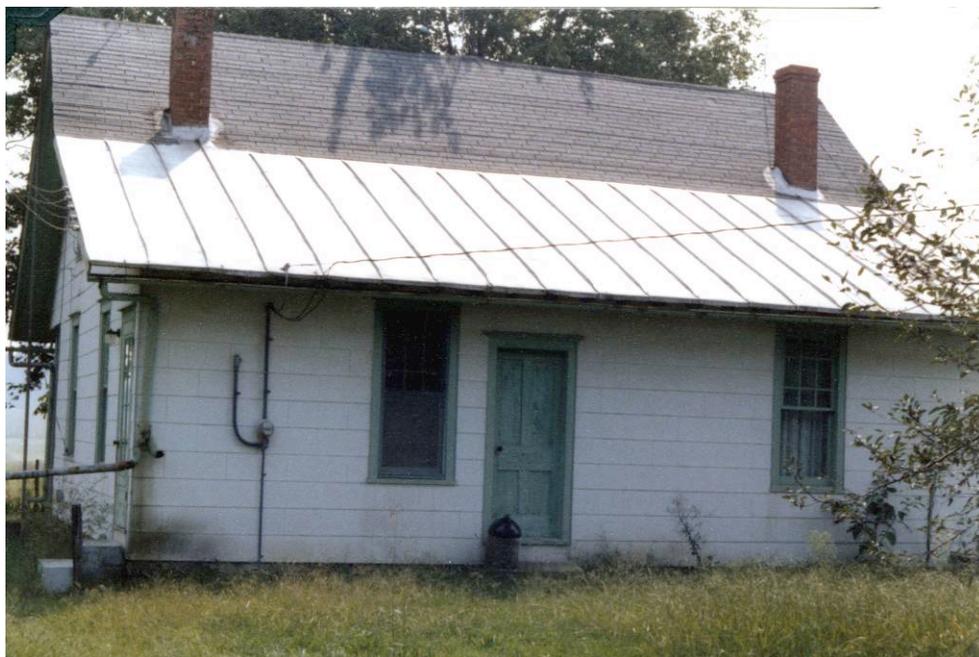
It is tempting as one looks at the back of the house to think that the rear portion under the tin roof is an addition. Let's keep in mind two things as we return to the front and side view to see if we can decide about this: 1) the center row of glass panes in the right hand

window is taller than the lower row and the upper row, and 2) note the character of the trim to the doorframe above the door.

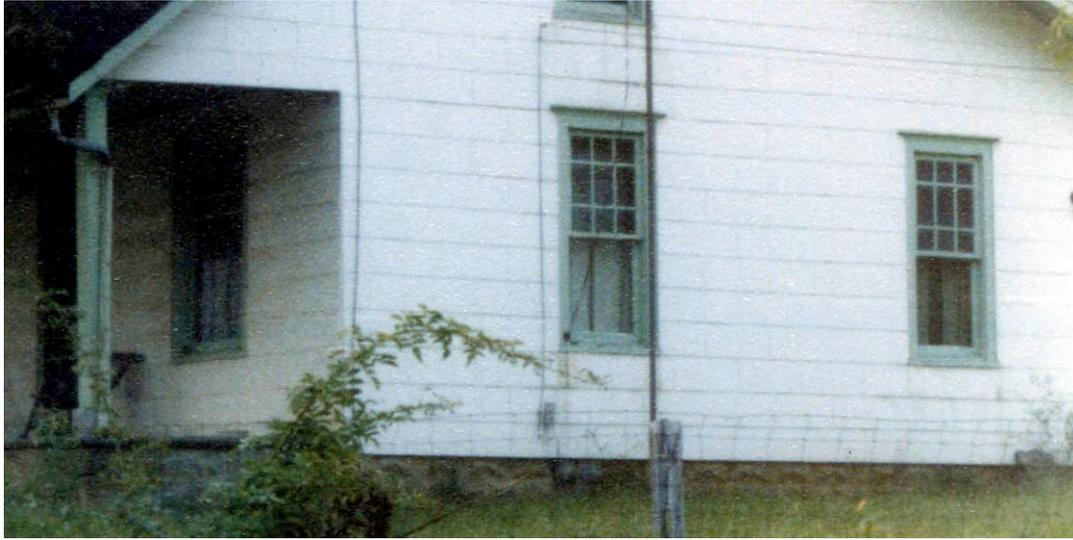
At the windows on the side, the center row of panes is distinctly higher than the upper and lower rows, and we see the same decorative treatment of the frame at the top of the all windows and doors, both side and back.

A third point also speaks in support of both parts of the house being of the same construction. There is no seam or break in the stone foundation between the two parts of the house. We can conclude this to be all of one construction. Let's look at the floor plan of the house to see if we can better understand this house.
