SMOKE HOUSE DOCENT TOUR

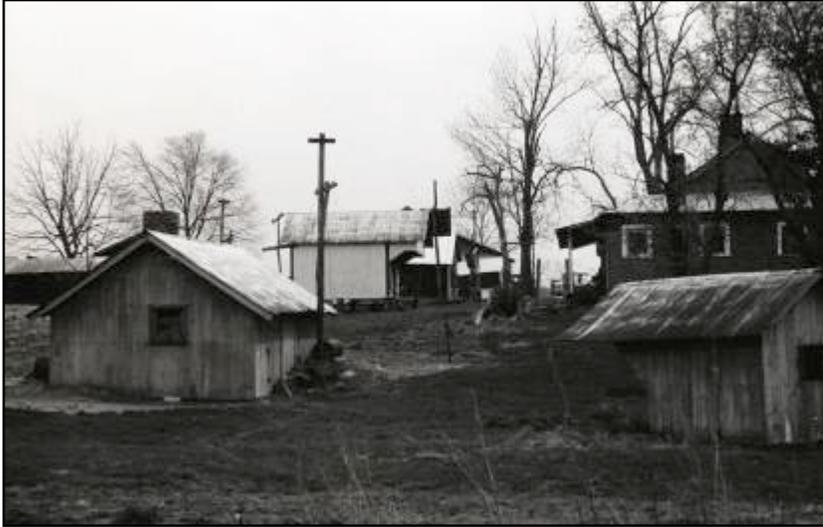
We saw evidence at the Bretz farm that there is coherence and order in the arrangement of buildings, though things may not necessarily be arranged in a linear fashion.

Here on the Walden farm we see most building at right

angles to one another, suggesting a similar kind of order. We can suspect however, that not all of the buildings were laid onto the landscape at the same time. How might one decide something about the time period in which individual buildings appeared? For that matter, how does a folklorist look at buildings? The white building near the center can give us some clues about age and use.

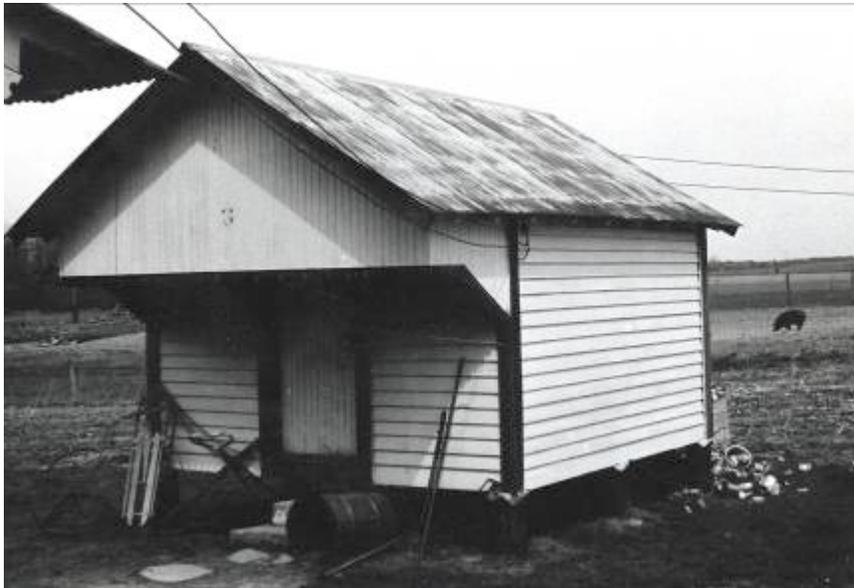
This is the smokehouse. It is square, measuring 12 feet 1 inch on each side. The overall appearance of the small building with the projecting gable overhang on one side appears in buildings serving many purposes.

This general shape might be used for a bake oven, a smoke house, a wash house a summer kitchen, etc. Folklorists think of such shapes in terms of “form,” enabling them to relate one building to other buildings serving different purposes. Since it is a smokehouse, it must safely contain a fire, tightly contain smoke, be properly ventilated to sustain the fire, be high enough to hang meat 6-8 feet above the fire, and be vermin free.

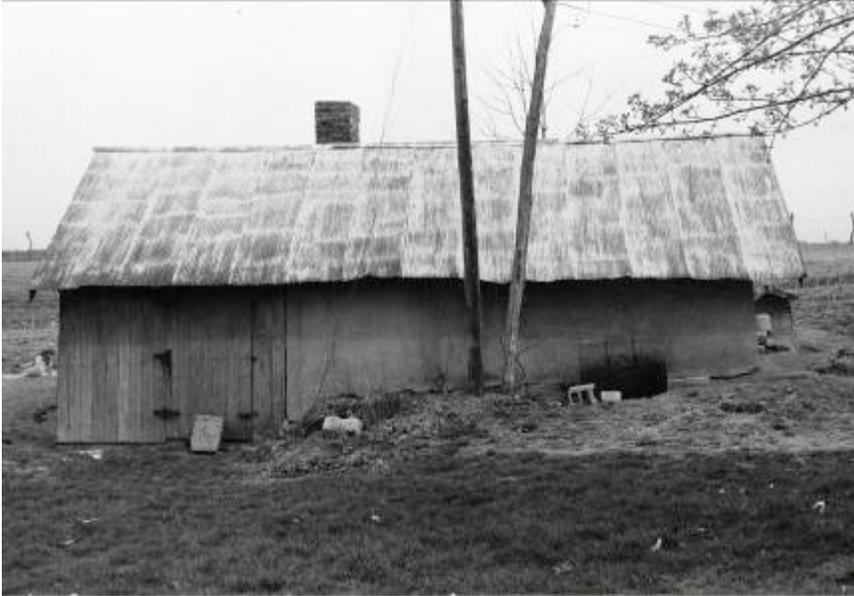
On the organized landscape of the farmstead, this nearby building has an important relationship to the smokehouse. This is the cold cellar building.

Butchering normally took place in late fall after the frost and before much snow. The freshly butchered meat was cooled

down here, prior to salt curing, and prior to smoking it was often cured in this cool environment in crocks or barrels for one-to-three weeks or more. After smoking, if it was to be kept for a long time, it was dry rubbed with a home-made preparation to protect it from vermin and then carefully wrapped in parchment or newspaper to be hung in this cellar for use in the coming winter.

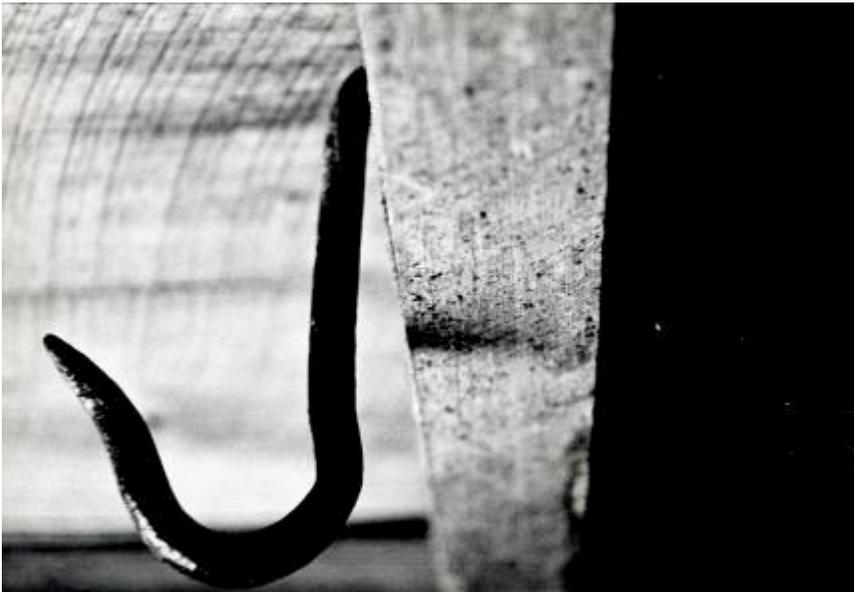
These observations will tell us something about both age and use. (Well, it will tell us how old the building isn't.)

The circular marks on the board in the ceiling above the hook are from a circular saw, which came into general use in the decade of the 1850s. So in its present form, the

building is late 19th century or early 20th century. There are much fainter and also circular marks on the joist into which the hook is set. The large hook itself as a good

indication that the building did indeed serve as a smokehouse. A heavy coating of soot on the walls and ceiling will be another good indication.

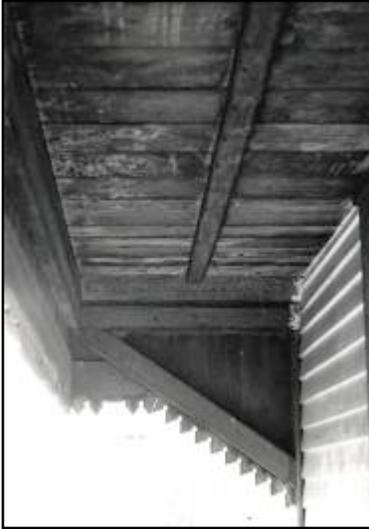
As down to earth and functional as the building was in the round of daily life on the farmstead, the family communicated to the community something about themselves in the attention they gave to the details of the building. The fresh coat of white paint and the darker trim makes a statement about how we view ourselves, as does the workmanship of the decorative trim.

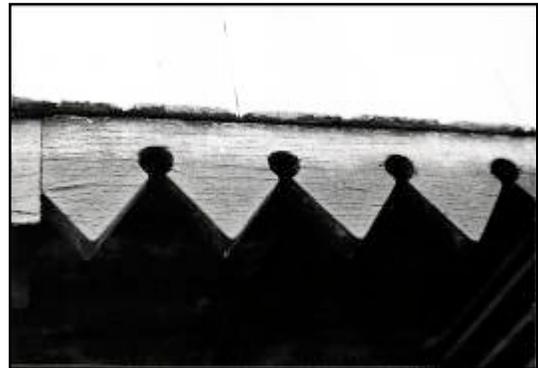
This decorative trim was created by drilling carefully spaced half inch holes in a poplar board, and then using a keyhole saw (a very narrow saw blade) to start in the hole and saw diagonally in two directions to create the teeth of the design. We spoke early of form as being stable and unchanging relative to how the building might be used. These trim details are matters of style, and do frequently change according to time, location and social position.
